Rail Accident Investigation Branch

# Rail Accident Investigation: Interim Report

**Collision near London Waterloo station,  
15 August 2017**

Report IR2/2017  
December 2017

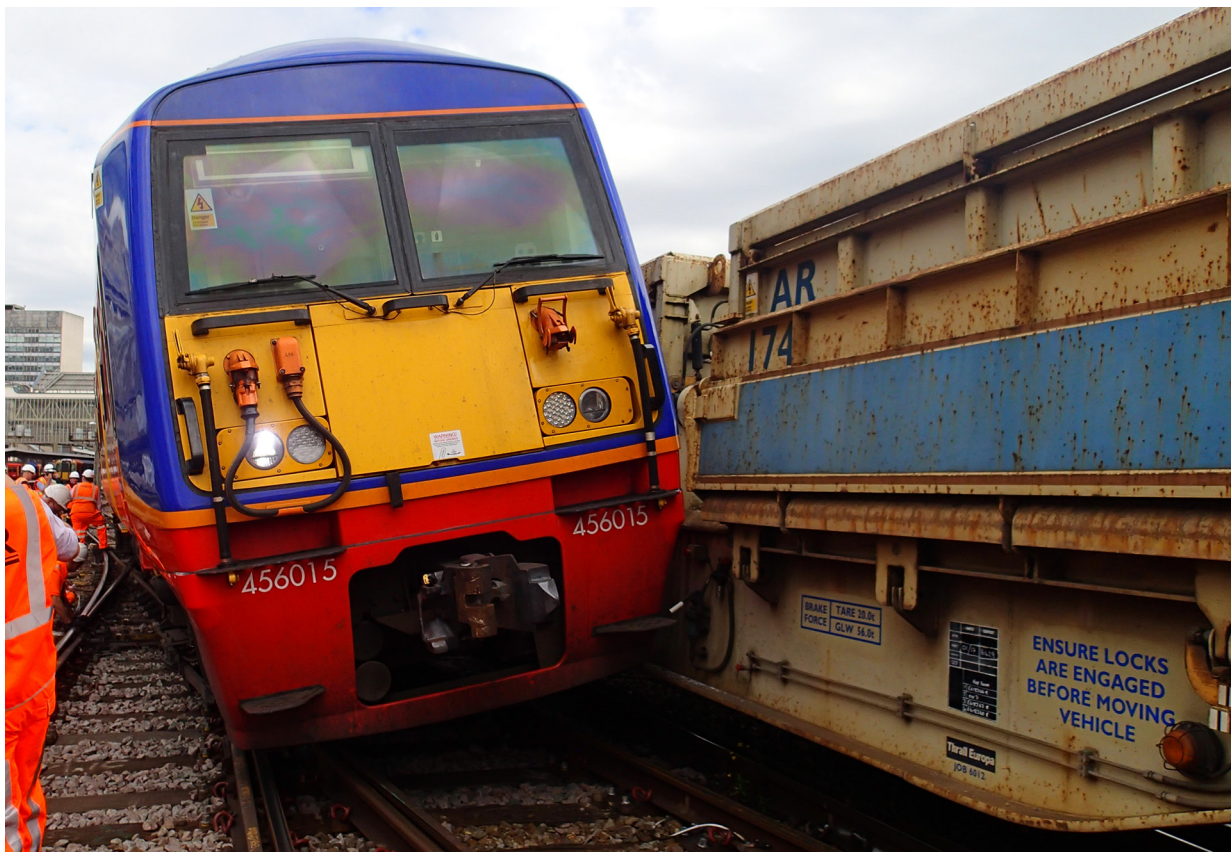
- 1 At around 05:42 hrs on Tuesday 15 August 2017, a passenger train leaving London Waterloo station and travelling at about 13 mph (21 km/h), collided with a stationary engineering train. There were no injuries, but both trains were damaged and there was serious disruption to train services.

- 3 The collision occurred because a set of *points*<sup>1</sup> was not in the correct position and directed the passenger train away from its intended route. When the train passed over them, the points were in this position because of a temporary modification to the points control system, which also caused the train driver and signaller to receive indications that the points were correctly set.

Figure 1: Passenger and engineering trains after the collision

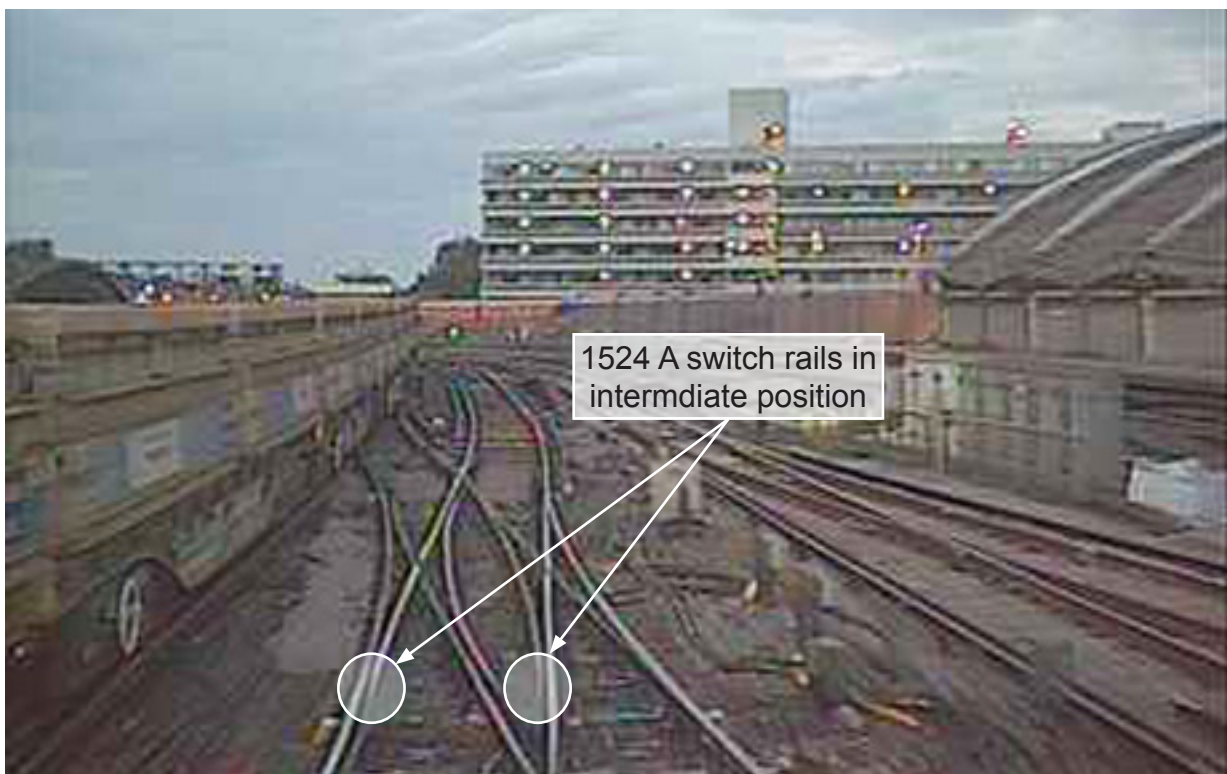
- 20 The collision occurred at 05:42 hrs as train 2D03, the 05:40 hrs Waterloo to Guildford service, was leaving platform 11. When the front of the train was around 65 metres from the platform end, and while travelling at 15 mph (24 km/h), it was directed to the left on 1524 A points and collided with the engineering train. Images from forward facing CCTV equipment shows that both *switch rails* of 1524 A points were lying midway between their normal and reverse positions (figure 4).
- 21 The driver had noticed that the points were not correctly set and applied the train's brakes around 3 seconds before the collision. This reduced the train's speed from 15 mph (24 km/h) to 13 mph (21 km/h) prior to the impact. The train came to a stop with the left hand wheels of the leading coach above the left-hand rail.

Figure 4: View from the train's forward facing CCTV of 1524 A points lying midway between normal (left switch rail closed) and reverse (right switch rail closed) (see appendix)

- 22 No one was injured, although there was some damage to the leading coach and to the engineering train. The accident caused severe disruption.
- 23 The train was directed to the left because the points which should have been set in the normal position were incorrectly lying in an intermediate state, close to the reverse position. The signalling system incorrectly indicated that the points were correctly set and safe, which meant that neither the signaller nor the driver were made aware of a problem.

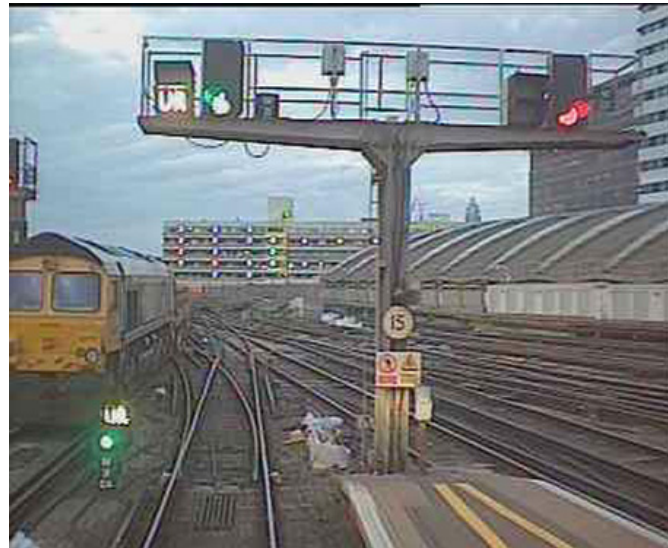
Figure 5: View from the train's forward facing CCTV of the green signal and 'UR' (Up Main Relief) route indication, duplicated at high and low levels, at the departure end of platform 11

- 34 The signaller set the route for train 2D03 to depart and proceed along the up main relief line. Having received notification from the guard that the train was ready to depart, the driver of 2D03 checked he had the correct route indication and proceed signal before starting his train. The train reached 1524 points and was directed towards the engineering train and the collision occurred. One of the consequences was that the train damaged 1525 points which caused an Out Of Correspondence<sup>5</sup> indication to flash on the Wimbledon signaller's panel.

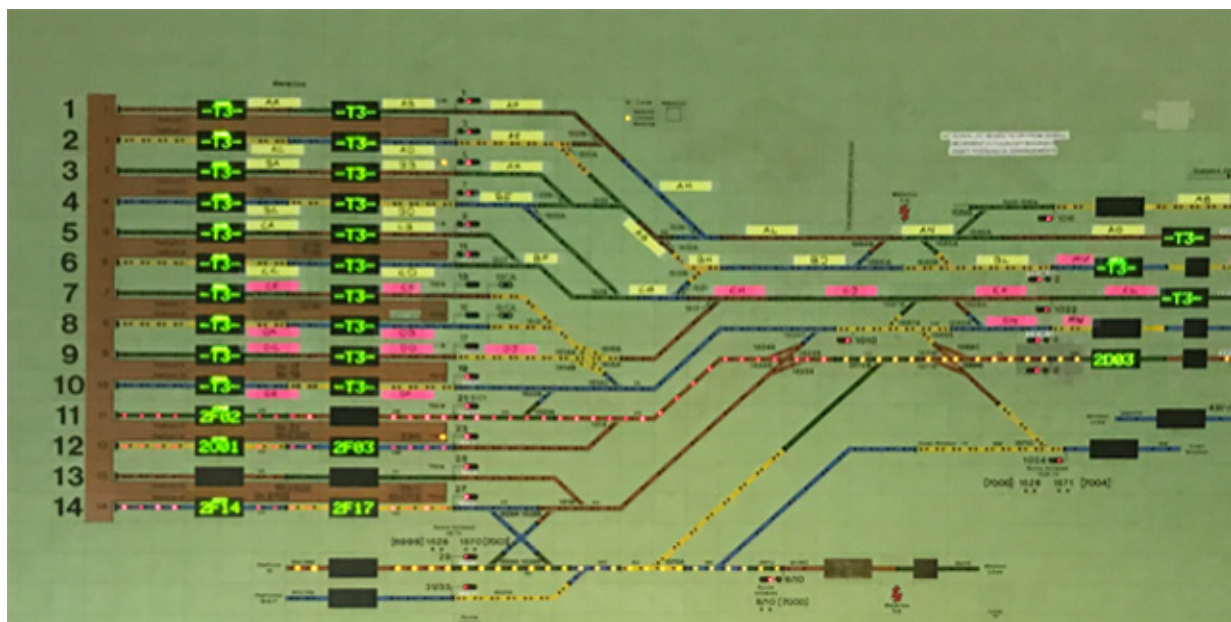
Figure 6: Signaller's view: the section of Wimbledon ASC panel showing the route out of platform 11, set for and occupied by train 2D03 (note that the engineering train was not displayed to the signaller, because indications on that part of the panel had been disconnected as the area was a worksite, not an operational railway).

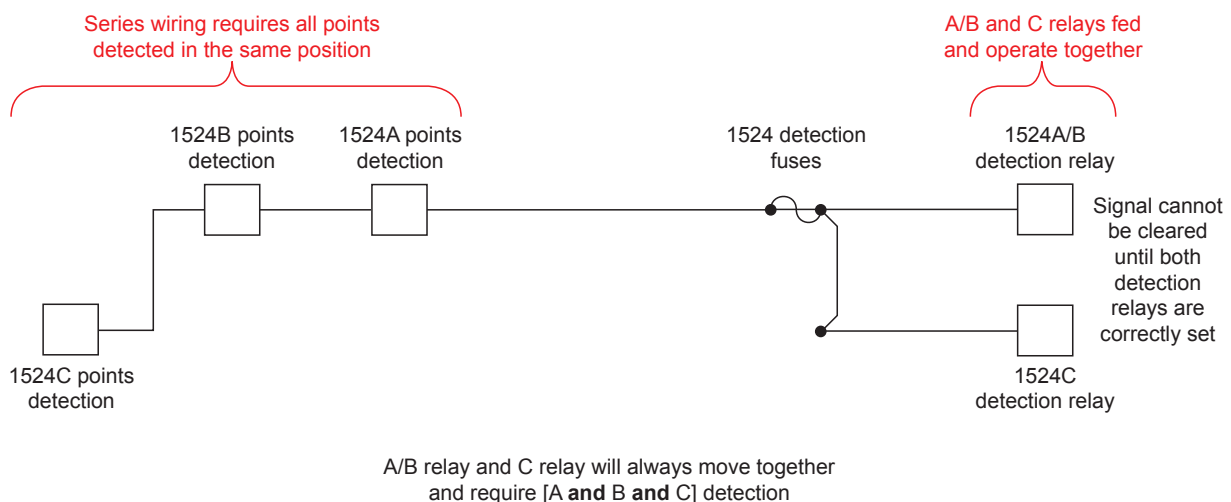
- 25 Before the works began, the point detection for 1524 points had the detector for each end wired in series, meaning that all three ends must be in the same position before any current was returned to the detection relays. This current was then used to power the relays for 1524 A and B and 1524 C detection (figure 7a). Further circuitry required both detection relays to be correctly energised before trains were permitted to approach 1524 points.

Figure 7a: 1524 points detection wiring as installed before work began

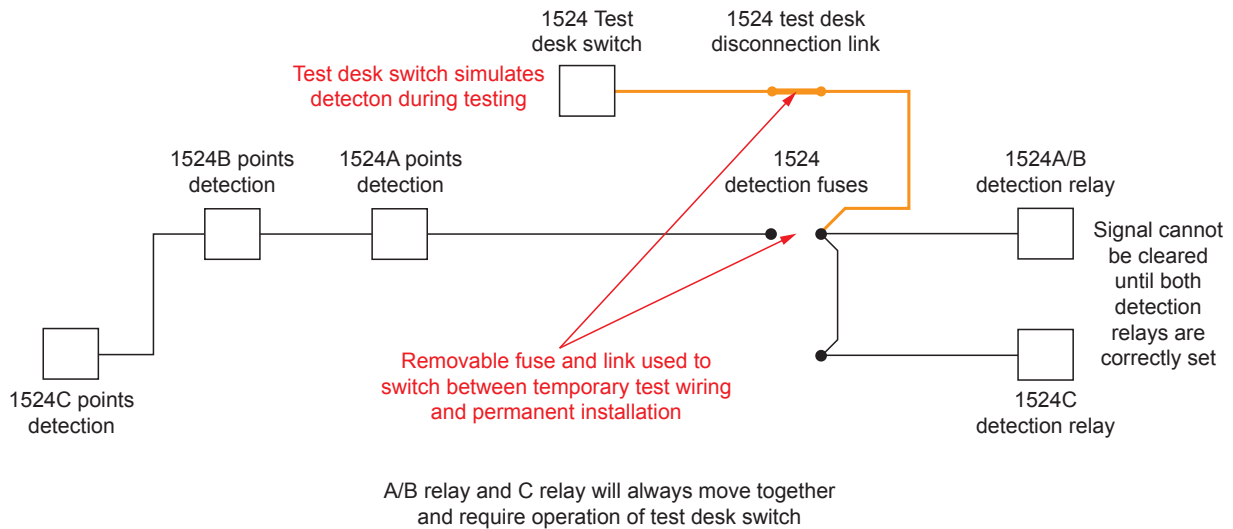
- 26 The signalling system had been fitted with a test desk, in advance of the August 2017 partial closure, to enable signalling functions to be simulated, so aiding testing during the works. This had been designed based on the signalling system wiring which existed in June 2016 and was installed and tested in August and September 2016. The test desk was only permitted to be used while trains were prevented from operating, and so the signalling testers had a process for removing fuses from the operational circuits and inserting *links* into the test desk circuits to use the test desk. This process was reversed before the line was restored to normal working (figure 7b).

Figure 7b: 1524 test desk wiring as designed (shown when test desk in use)

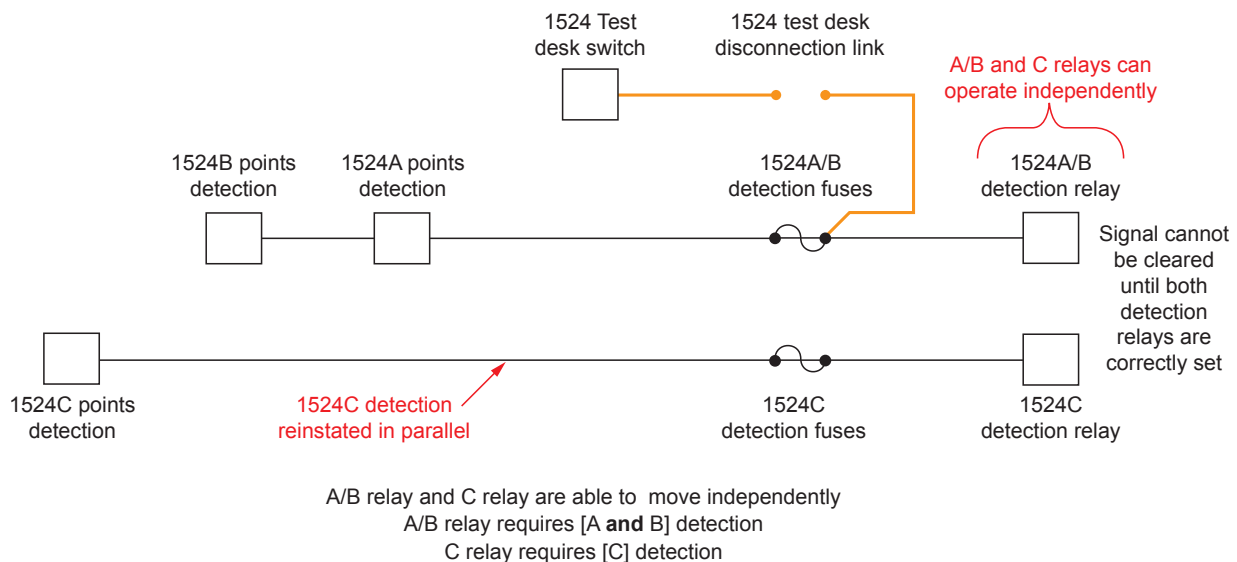
27 To make room for the new station layout, it was necessary to relocate a track-side signalling location case, W14, which contained part of the wiring for the detection circuits for 1524 points. As part of the relocation, the design of the point detection wiring was modified to bring it in line with typical modern design. The detection for 1524 A and B points was now being returned to the relays on a separate circuit to the detection for 1524 C (figure 7c). As in paragraph 24, further circuitry required both detection relays to be correctly energised before trains were permitted to approach 1524 points, so the safety of the signalling system was unaffected by this change.

Figure 7c: change of circuit design: after location W14 abolished (shown with test desk 'switched' out)

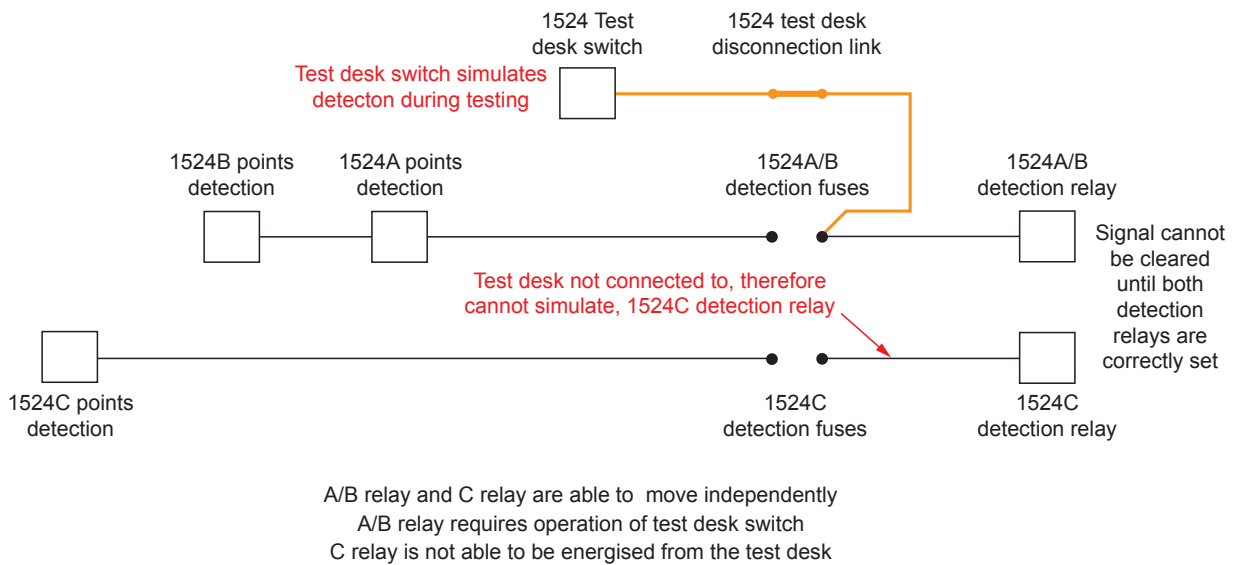
28 The modification to the wiring of the point detection circuits in location case W14 and Waterloo relay room during the partial closure of Waterloo Station meant that the test desk no longer simulated the detection of 1524 points correctly because 1524 C points were no longer included in in the circuit that the test desk switch was connected to (figure 7d).

Figure 7d: 1524 points in test mode after location W14 abolished

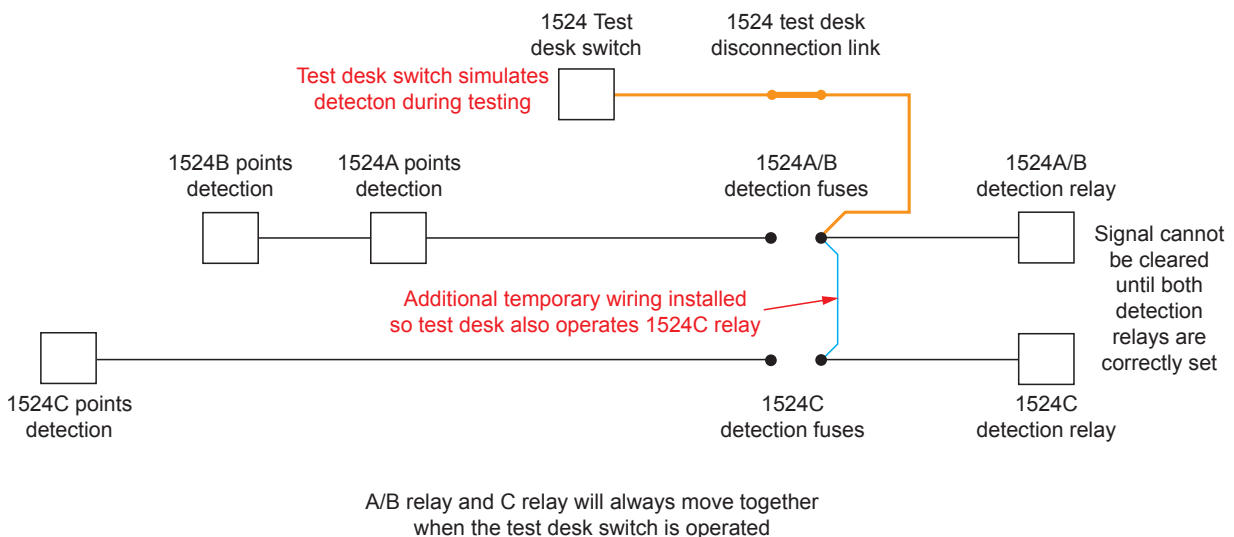
29 On the weekend of 12/13 August 2017, while trains had been stopped from running on the lines leading to 1524 points, a temporary wiring modification was made in the relay room in an attempt to restore the correct operation of the 1524 points test desk switch. This modification (figure 7e) was not reviewed by a signalling designer and was incorrectly left in place when the railway was returned to operation on the morning of 14 August. Contrary to Network Rail standards, no test log or modification record has been found, and the RAIB is still investigating the exact circumstances surrounding the installation of this temporary wiring modification. Leaving this modification in place when the railway was returned to operation had the effect of changing the logic between the point detection and the relays so that if either 1524 A and B or 1524 C point ends were detected on the ground, the system reported all ends detected.

Figure 7e: 1524 points at time of testing, temporary wires added so that the test desk operated both sets of relays

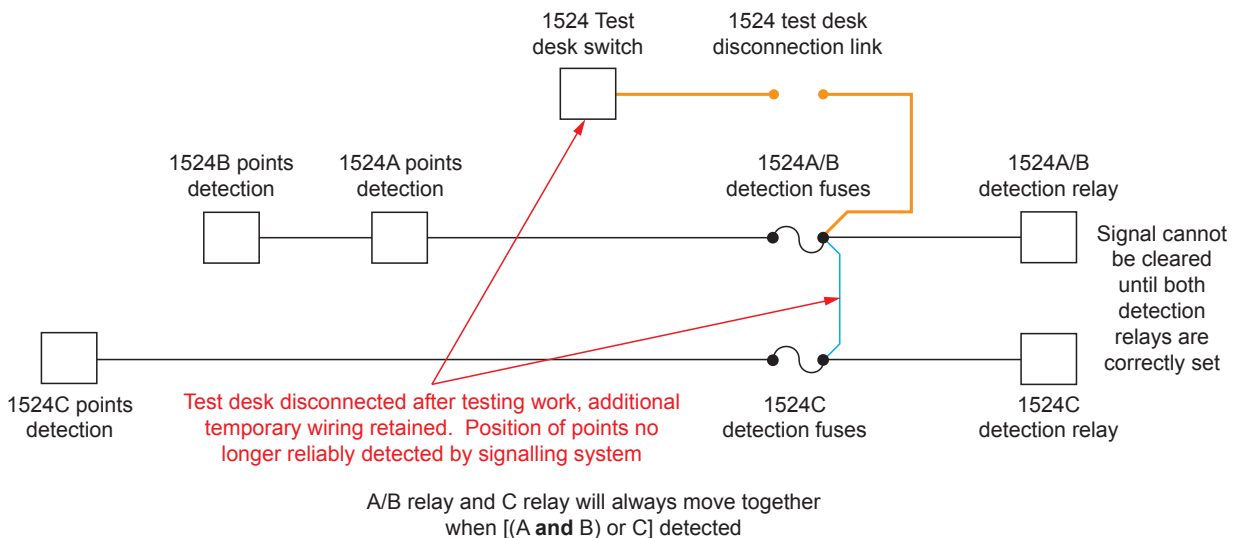
- 30 During the night of 14/15 August, signalling testers at Wimbledon Area Signalling Centre (ASC) were checking signalling routes into Waterloo station. One of these routes required 1524 points to be called reverse (commanded to reverse position). The tester believed that all ends of 1524 points were secured in the normal position<sup>3</sup>, so did not expect them to move.
- 31 When 1524 points were called reverse, the A and B ends were free to move to the reverse position. The C end remained in the normal position as this end had been clipped in the normal position. As a result of the temporary wiring in the relay room (figure 7f), once A and B reached the reverse position all three ends of the points would have registered as reverse in the signalling system.

Figure 7f: 1524 points detection at time of derailment

- 32 When the route was cancelled and the testers returned the points switch on Wimbledon ASC signaller's panel to the normal position, points 1524 A and 1524 B began to move to the normal position. When the points had been moving for around one second and reverse detection was lost, normal detection was gained via the correctly detected C end and the temporary wiring. As soon as this normal detection was obtained, the power to the point motors was cut, resulting in the points remaining unlocked<sup>4</sup> and at, or close to, the reverse position.
